**BLUE LOGIC**

Drawing title:  
40ml Compensator

Drawing number:  
BA1421

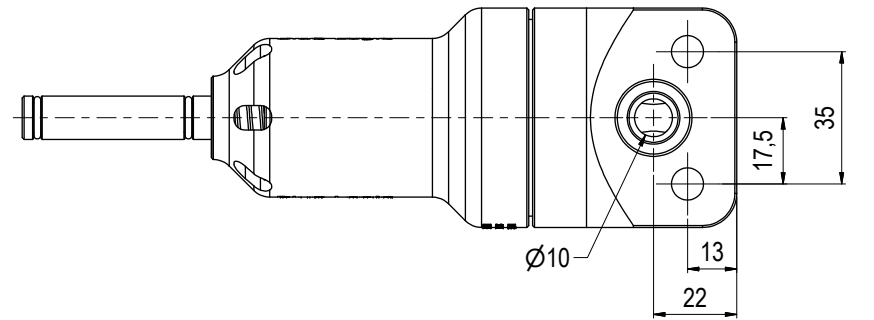
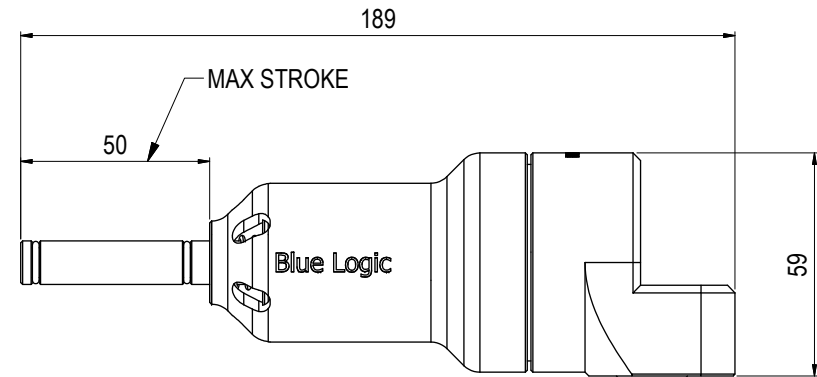
NOTE:  
To verify that all air  
has been removed,  
piston rod should feel  
firm and should not move  
if pushed in.

Optional Equipment:  
Pressure Relief Valve  
Type:BA1382 3/8" BSP.  
(Avoide damage pressure)

NOTE: 3  
INTERFACE INFORMATION:  
Pressure Rating Bar: N/A  
Material: Intervention  
Weight: 1,2 kg  
Volume: 0,18 dm^3  
Surface Area: 743 cm^2  
Hydraulic: 40ml Compensator  
Mechanical: N/A  
Electrical: N/A  
Com. & Protocol: N/A
